DEPARTMENT OF DEFENCE DEFENCE SCIENCE AND TECHNOLOGY ORGANISATION **AERONAUTICAL RESEARCH LABORATORIES**

Structures Technical Memorandum 303

A REVIEW OF AUSTRALIAN INVESTIGATIONS ON AERONAUTICAL FATIGUE DURING THE PERIOD **APRIL 1977 TO MARCH 1979**

G.S. JOST

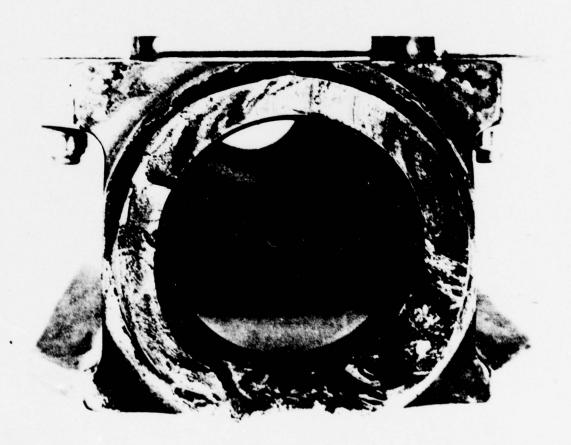
Another type of less common but none the less recurring propeller problem is examplified by the mid-span failure shown in Fig 9.57. In this instance the failure initiated at a point of corrosion attack 0.75 mm long and 0.15 mm deep on the front or camber surface of the blade. The corrosion attack appeared to follow a path along a strain line within a single grain at the blade surface. This form of corrosion, although very serious as a stress raiser, is very difficult to detect visually. The rate of crack propagation appeared to be very rapid, possibly a few flights, thus the problem is difficult to detect "in esse".

FIG. 9.5 PROPELLER FAILURE INITIATING AT CORROSION ATTACK (Magn. x 1.1 approx.)

Presuming that the re-straightening operation was carried out within the manufacturer's prescribed limits, there is a case for recommending that these limits be revised, even to the extent of prohibiting re-straightening in this critical mid-span section.
